TYPE 1 RECONNAISSANCE LEVEL CHARACTERIZATION REPORT (RLCR)

BUILDING T707E CLOSURE PROJECT

REVISION 0

May 3, 2005

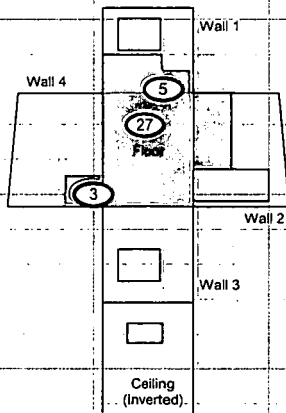
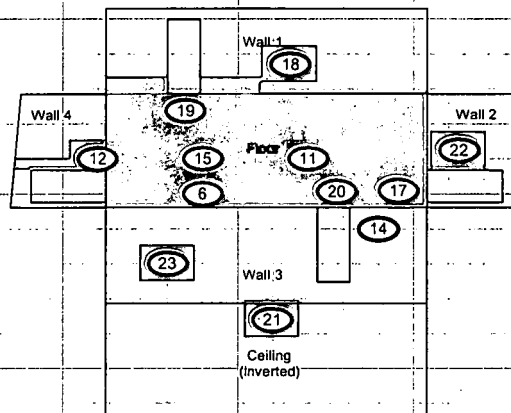
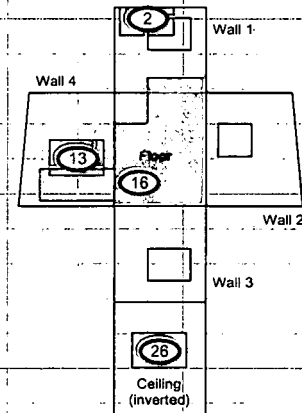
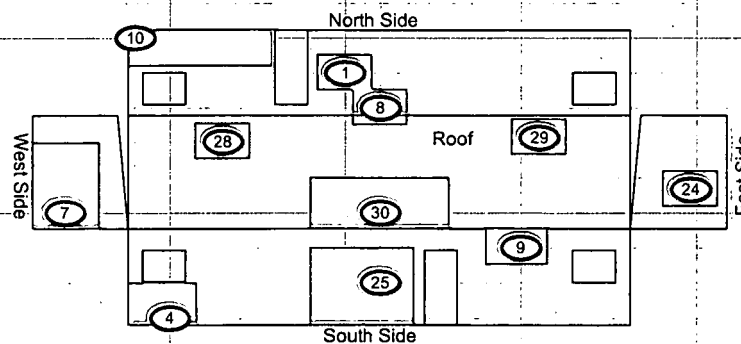
Survey Area: 0**Survey Unit:** 707E01**Building:** T707E**Description:** Trailer 707E (Interior and Exterior) all surfaces

Conclusion - A comparison of the random, biased and QC measurement results against the PDSP Table 7-1 Surface Contamination Guideline limits was conducted; the comparison demonstrates that this survey unit passes the criterion specified in the PDSP.

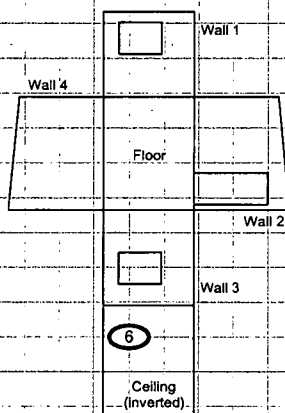
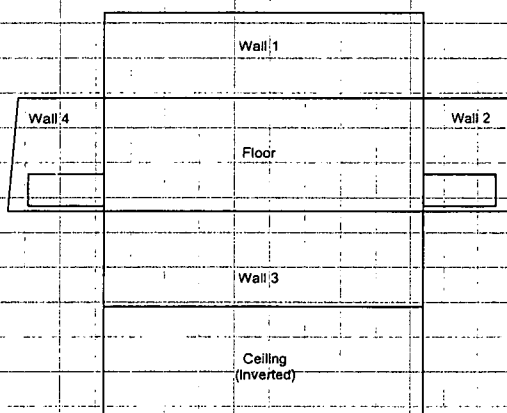
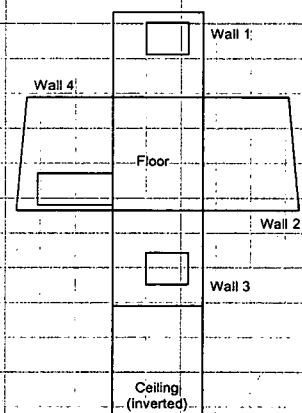
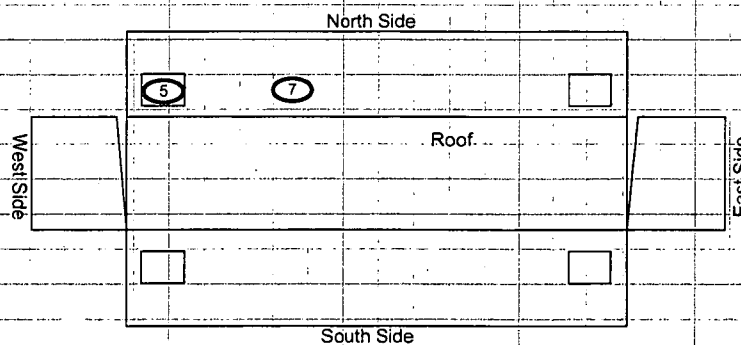
- Asbestos Sample Location
- Beryllium Sample Location
- Lead Sample Location
- RCRA/CERCLA Sample Location
- PCB Sample Location

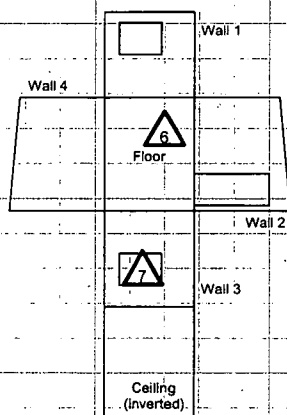
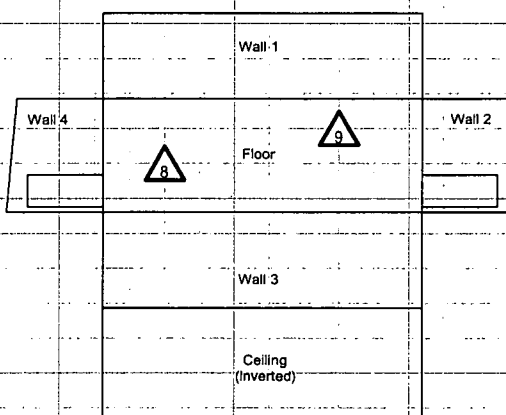
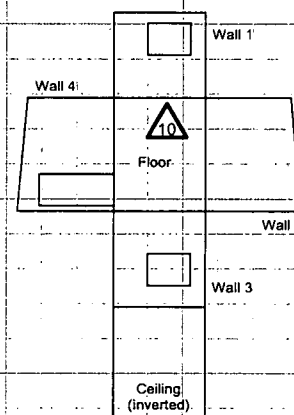
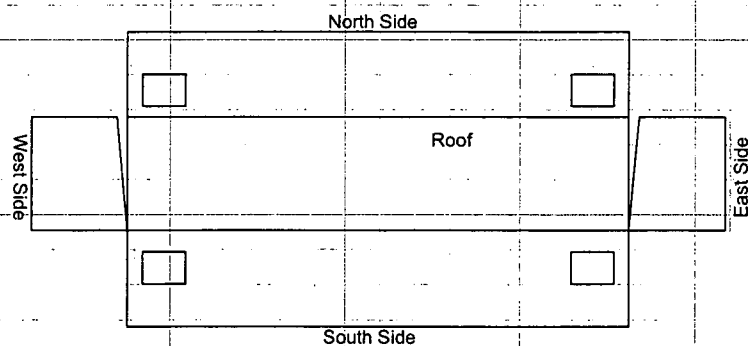
- Asbestos Sample Location
- Beryllium Sample Location
- Lead Sample Location
- RCRA/CERCLA Sample Location
- PCB Sample Location
